How to resolve the error message

This is the list of error messages displayed in md-gear screen and their answers. If an error is not resolved even if you do the corrective action described, or if the error message is not described below, please contact the Customer Support & Service Center. These code types (NC, F, S, T, H, X, Y, Z, G, M, O, L, A, and B) are displayed in "%" in the message.

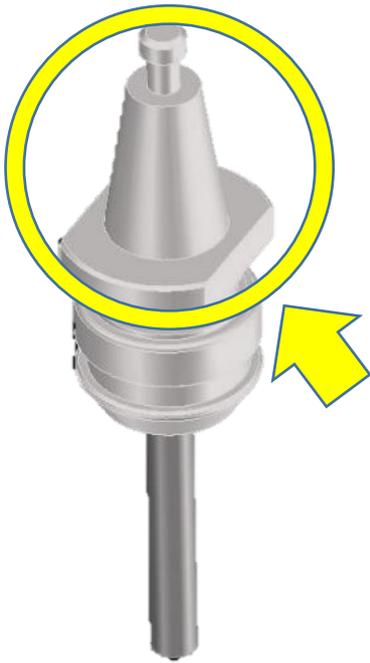
Remove any chips on the collet holder taper or in the spindle's taper.

↑ collet holder of milling tool

For details, refer to “2 Cleaning the Inner surface of the spindle” in the Cleaning Guide.

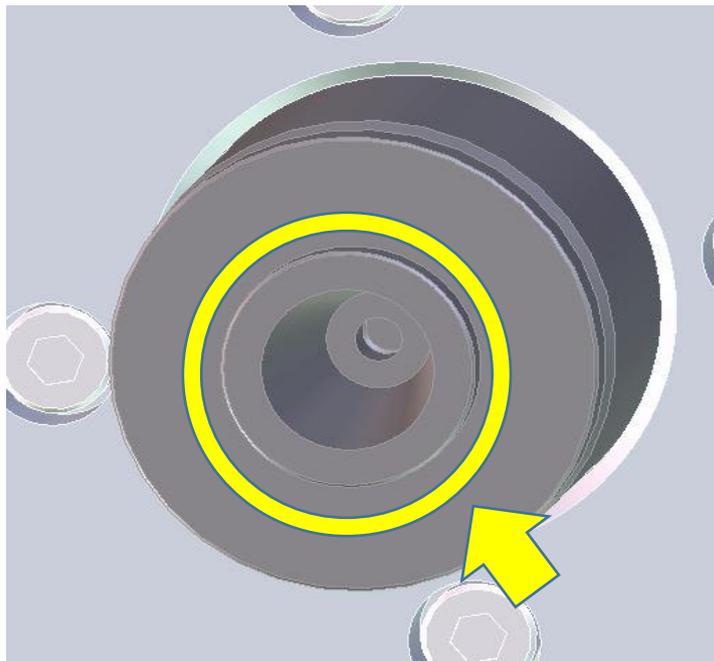
↑ spindle (underside)

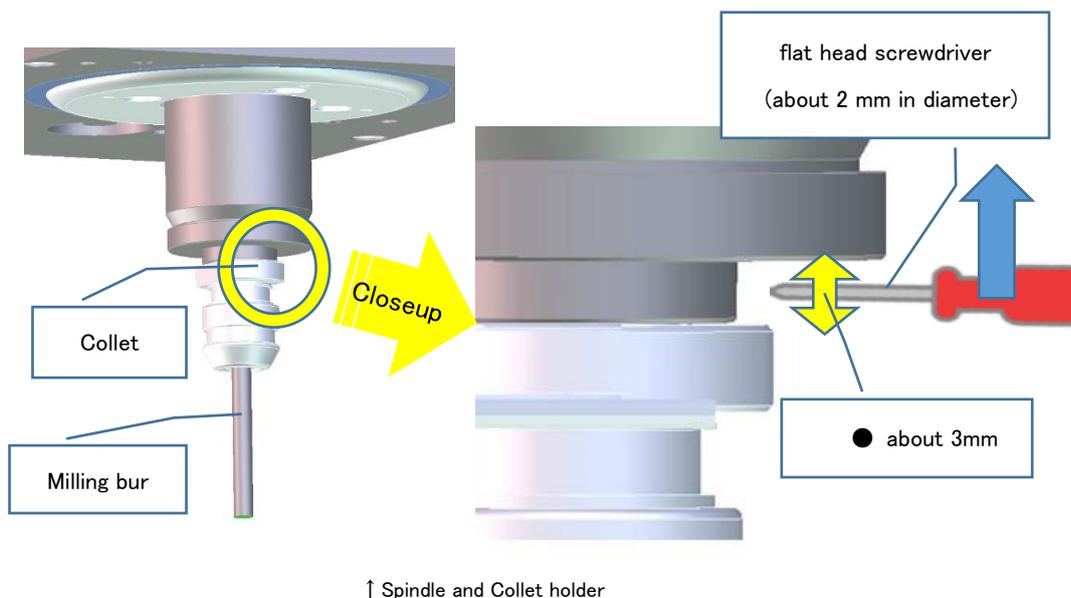
2. Replace the collet holder and try the operation again.
3. If the error still occurs, find out its cause as following below.
 - I. Set your smartphone's camera to front camera and place it on the Swivel table.

- II. Look at the inner surface of the spindle on the screen of your smartphone and check if there are any foreign substances on the spindle.
 - III. If there are any foreign substances, remove them with a soft cloth.If the error still happened, please contact our Customer Support & Service Center.

The machine has attempted to store a milling tool in the ATC magazine, but the tool (and its holder) will not come out of the spindle even when the chuck is opened.
